# Manhole Inspection Summary

Manhole # S49M\_\_029MH

Insp Date: **12/3/08 10:24 AM**

**Location** Address: **2429 boston st**

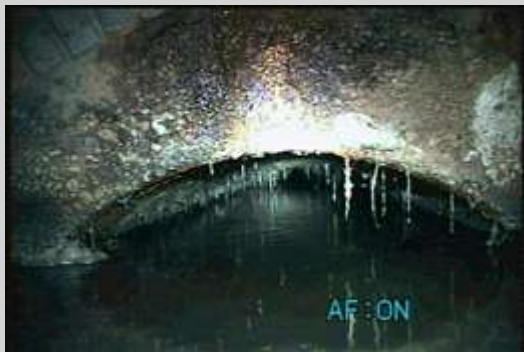
12 O'Clock Outflow

36 in. Circular Gravity Sewer  
Pipe Out @ 12 O'Clock

Invert Depth: **15.92** (ft.) Flow Characteristics: **Slow**

Infiltration: **None** Pipe Seal Cond: **Unknown**

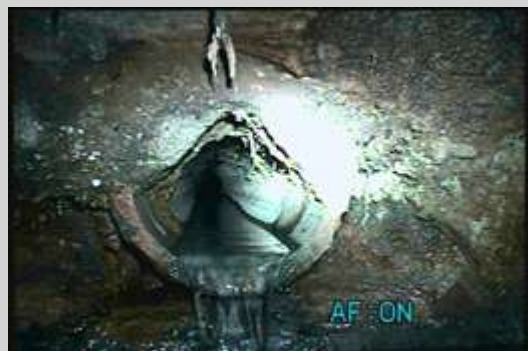
9 O'Clock Inflow

8 in. Circular Gravity Sewer  
Pipe In @ 9 O'Clock

Pipe Material: **Clay** ☐ Pipe Lined

Infiltration: **None** Pipe Seal Cond: **Unknown**
